Manhole Inspection Summary

Manhole # S43Y1_005MH

Insp Date: **5/14/08 9:25 AM**

Location Address: **3500 9th St.**

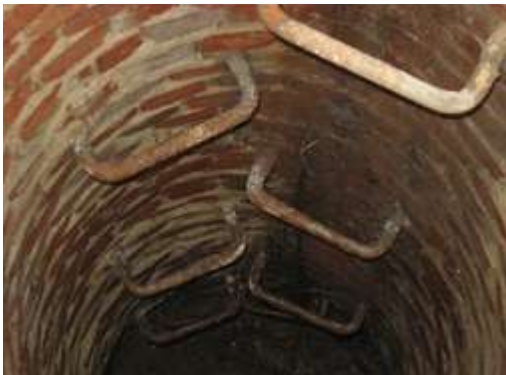
Steps

Count: **10** Missing: **0** ☒ **Corroded**

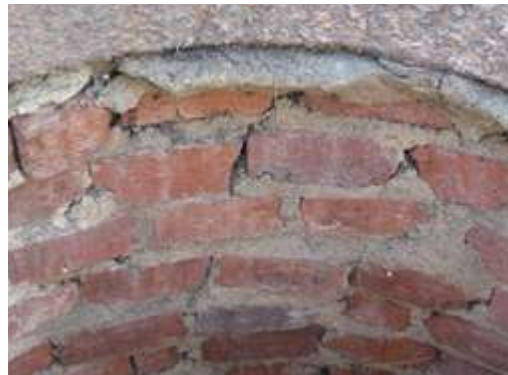
Defect 1

Condition: ☐ Sound ☐ Cracked ☒ **Root Intrusion** ☐ Loose Brick ☐ Deteriorated

Infiltration: ☐ None ☒ **Joint** ☒ **Cracks** ☐ Mortar ☒ **Roots** ☐ Wall

Frame-Chimney Joint (root intrusion and crack)

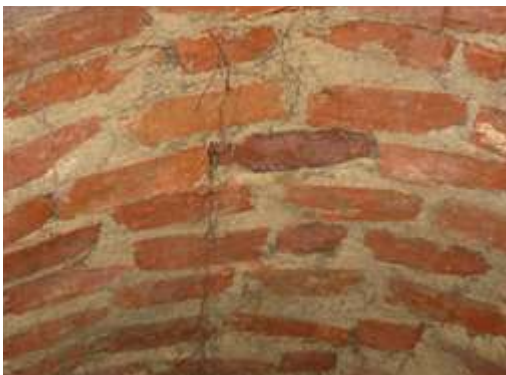
Defect 2

Condition: ☐ Sound ☐ Cracked ☒ **Root Intrusion** ☐ Loose Brick ☐ Deteriorated

Infiltration: ☐ None ☐ Joint ☐ Cracks ☐ Mortar ☒ **Roots** ☒ **Wall**

Root intrusion on the wall

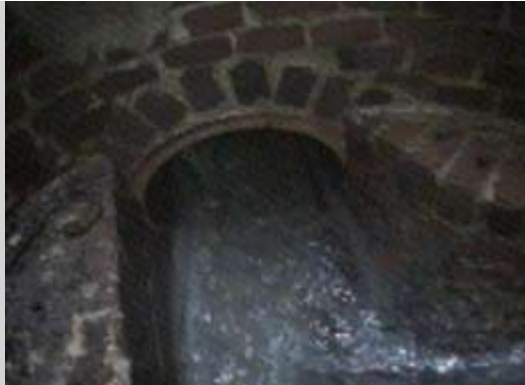
12 O'Clock Outflow

15 in. Circular Gravity Sewer
Pipe Out @ 12 O'Clock

Pipe Height: **3.6** (in.) Rod and Bar (Angled)
Pipe Material: **Clay** ☐ Pipe Lined
Invert Depth: **1.00** (ft.) Flow Characteristics: **Fast**
Deposits: ☒ None ☐ Mud ☐ Sludge ☐ Debris ☐ Grease
Silt Depth: (in.) Deposits Extent:
Infiltration: **None** Pipe Seal Cond: **Sound**

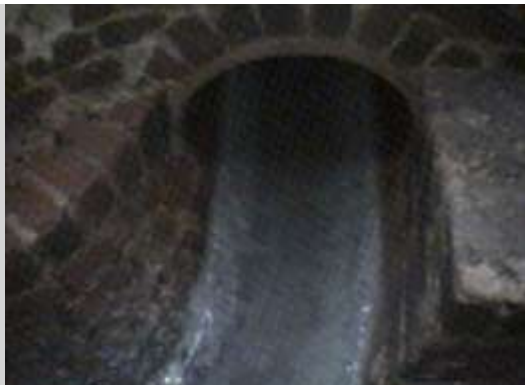
3 O'Clock Inflow

15 in. Circular Gravity Sewer
Pipe In @ 3 O'Clock

Pipe Height: **3.6** (in.) Rod and Bar (Angled)
Pipe Material: **Clay** ☐ Pipe Lined
Invert Depth: **1.00** (ft.) Flow Characteristics: **Turbulent**
Deposits: ☒ None ☐ Mud ☐ Sludge ☐ Debris ☐ Grease
Silt Depth: (in.) Deposits Extent:
Infiltration: **None** Pipe Seal Cond: **Sound**

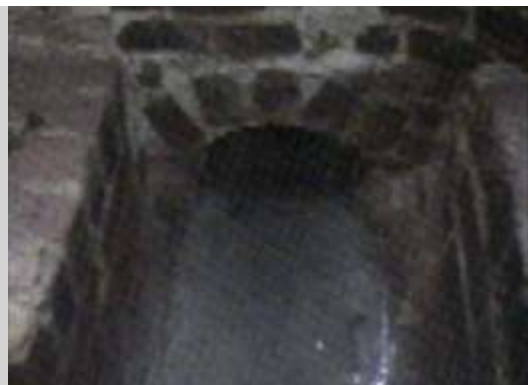
6 O'Clock Inflow

8 in. Circular Gravity Sewer

Pipe In @ 6 O'Clock

Infiltration: **None** Pipe Seal Cond: **Sound**
